ESL-TR-79-05

CASING LEAK DETECTION STUDY

JULY 1979

FINAL REPORT DECEMBER 1977-FEBRUARY 1979

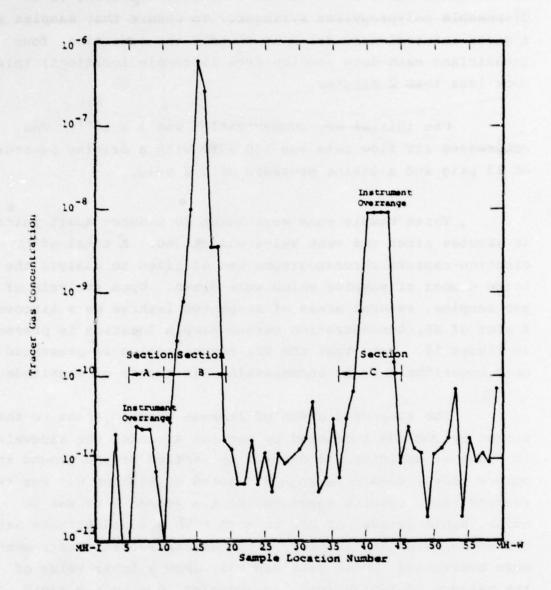
The suspected areas of leakage were adjacent to the street by Manhole I denoted by Section A; under the sidewalk in front of Building 614 denoted by Section B; and, around the corner midway toward Manhole W denoted by Section C. For two reasons these results suggested that a second test was in order. Rapid arrival of SF_6 in such high a concentration was not anticipated and in many instances, therefore, instruments were overranged. These data can only show a lower value of the maximum concentration. In addition, due to the rapid communication from these leaks, there is a nonzero background (on the order of 10^{-11}) which can be seen at many sample locations. However, it was fairly certain that there were three areas which required further study. They all had SF_6 peaks with concentrations of 10^3 to 10^5 times higher than the background.

Figure 29. NAS-NI Test 1 - Tracer Gas
Concentration on the Surface
Along Estimated Pipe Centerline

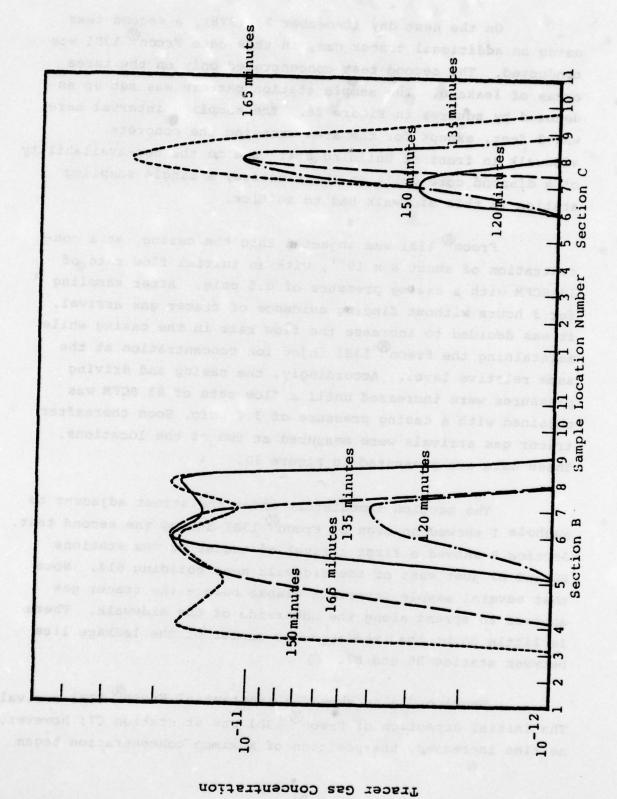
The section immediately under the street adjacent to Manhole I showed no sign of Freon 13B1 during the second test. Section B showed a first arrival of tracer at new stations B6 and B7 just east of the sidewalk near Building 614. Note that several sample intervals elapse before the tracer gas appears to spread along the underside of the sidewalk. There is little doubt that the apparent center of the leakage lies between station B5 and B7.

Section C also showed a substantial Freon[®] 13B1 arrival. The initial detection of Freon[®] 13B1 was at station C7; however, as time increased, the position of maximum concentration began

NAS-NI Test 2 Tracer Gas Concentration on the Surface Along Estimated Pipe Centerline at Section B and Section C Figure 30.

On April 17, 1979, the RIC-WIL pipe was uncovered near the suspected leak at Section B. A substantial leak was found within one foot of the tracer peak location illustrated in Figure 30. A significant additional fact is that the axis of the steam casing is four feet closer to the street
